*Posterior cervical fusion for trauma
using silicated calcium phosphate bone
graft substitute: A case report with 3-
year follow up.*

Jacob M. Drew, MD¹
Mark S. Eskander, MD¹
Michelle Aubin, MD¹
Patrick J. Connolly, MD¹

¹University of Massachusetts Medical School
Department of Orthopedic Surgery
Worcester, Massachusetts, USA

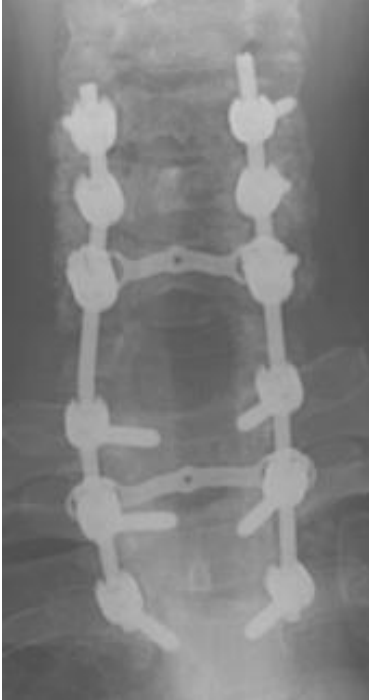
Figure 1. AP Radiograph 6 Months after Posterior Cervical Fusion

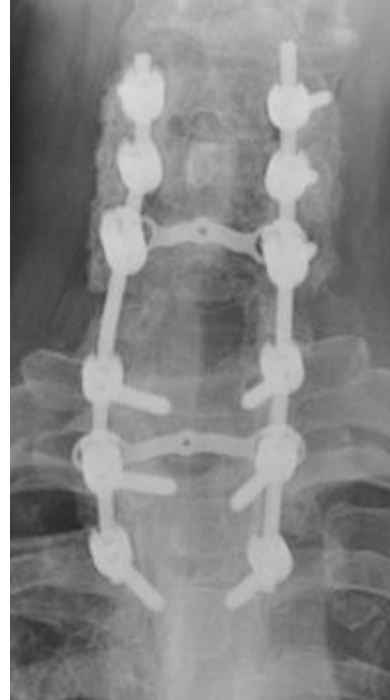
Figure 2. AP Radiograph 3 Years after Posterior Cervical Fusion

Purpose: This case report presents a young female trauma patient who was treated with posterior cervical fusion, using silicated calcium phosphate bone graft substitute (BGS) for a dislocation of C7 on T1. The purpose is to demonstrate that excellent clinical and radiographic fusion is attained using this commercially available BGS in the setting of cervical trauma. **Methods:** A 56 year old female suffered an unwitnessed fall down a flight of stairs, and presented to the emergency room with acute paraplegia. Sensory function is absent below the nipple line, and strength is 0/5 in bilateral lower extremities. Radiographs show bilateral jumped facets at C7-T1. The patient is immediately placed into a halo, and cervical traction is applied up to 50 pounds without reduction and only minimal improvement of overall alignment. The patient was taken emergently to the operating room, where an open posterior reduction is performed, along with posterior decompression at C7-T1 and posterior cervical fusion from C4-T3. Additionally, silicated calcium phosphate BGS is mixed with local autograft in a 1:1 ratio and placed in the posterolateral gutters to augment the fusion. **Results:** Postoperatively, the patient's neurologic exam has remained unchanged; she is a C7 paraplegic. As early as 6 months, radiographs demonstrate signs of solid bony fusion (Figure 1). At 3 years, radiographs show excellent bony alignment and evidence of solid fusion (Figure 2). **Conclusion:** Silicated calcium phosphate is a commercially-available BGS that is both safe and effective for use in the cervical spine following trauma as demonstrated in this patient at three year follow-up.
